Manhole Inspection Summary

Manhole # S67U__008MH

Location Address: **6300 Holabird Ave.**

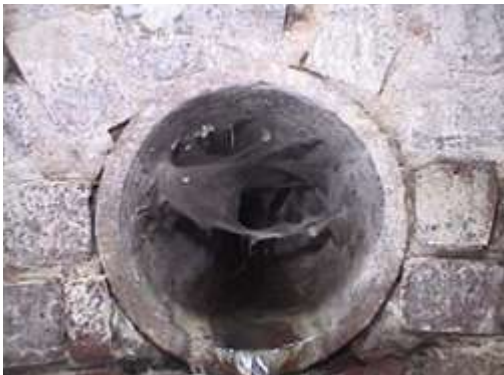
Defect 1

cracked pipe seal 5:00-7:00 incoming 3 O'Clock

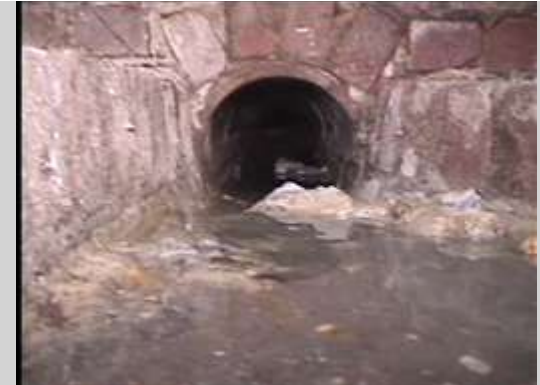
12 O'Clock Outflow

Pipe Height: **8.4** (in.) Rod and Bar (Angled)
Pipe Material: **Clay** ☐ Pipe Lined
Invert Depth: **7.33** (ft.) Flow Characteristics: **Fast**
Deposits: ☐ None ☐ Mud ☒ ~~Gravy~~ ☒ Debris ☐ Grease
Silt Depth: **1.5** (in.) Deposits Extent: **Light**
Infiltration: **None** Pipe Seal Cond: **Sound**

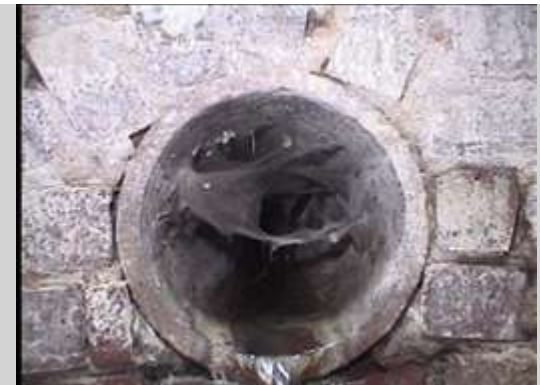
3 O'Clock Inflow

Pipe Height: **8.4** (in.) Rod and Bar (Angled)
Pipe Material: **Clay** ☐ Pipe Lined
Invert Depth: **5.79** (ft.) Flow Characteristics: **Fast**
Deposits: ☒ None ☐ Mud ☐ ~~Gravy~~ ☐ Debris ☐ Grease
Silt Depth: (in.) Deposits Extent:
Infiltration: **Evidence** Pipe Seal Cond: **Cracked**

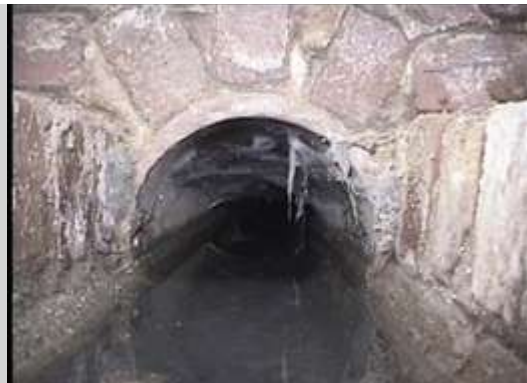
6 O'Clock Inflow

Deposits: ☐ None ☐ Mud ☒ **Sludge** ☐ Debris ☐ Grease

Silt Depth: **0.5** (in.) Deposits Extent: **Light**
